American Home Inspections of NE NC

Property Address US Coast Guard Housing, Unit #46017

Inspector Name Ralph W. Woodard, NC Licensed Home Inspector #493
Company Name American Home Inspections of NE NC
Company Address PO Box 2347
City Kitty Hawk State NC Zip 27949
Phone Cell 25 202 8344 Fax x
E-Mail ralphdubya@embargmail.com

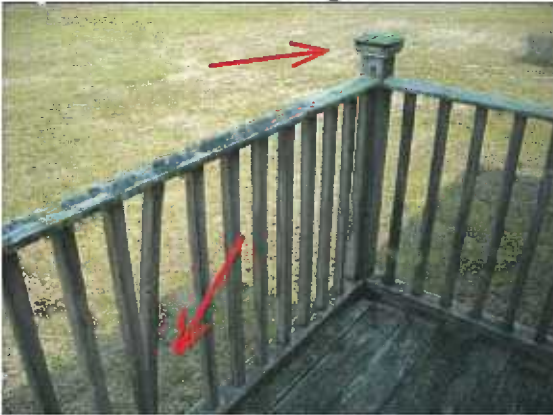
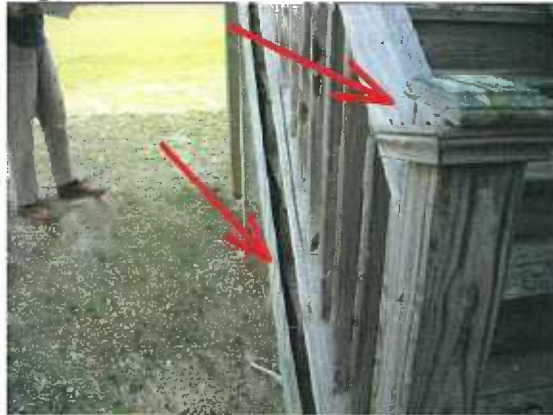
1. **Stairs/Landing: Rear Stairs & Landing, Pressure Treated Wood** There is on trim board along the stair steps, the nails are becoming loose and the board is pulling away from the steps. The decorative wood trim at the top of the handrail post, most of this trim is missing or deteriorated. The wood pickets are loose or out of place. The nails used to secure the pickets are rusty/deteriorated.

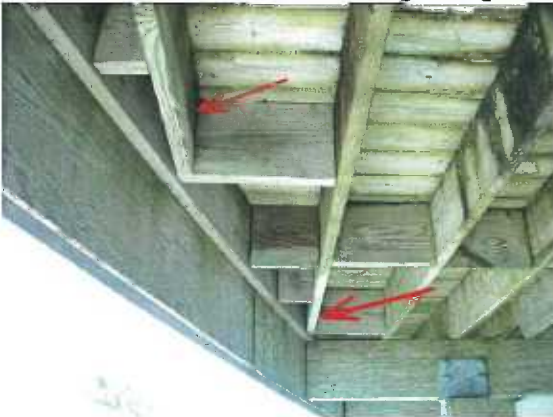
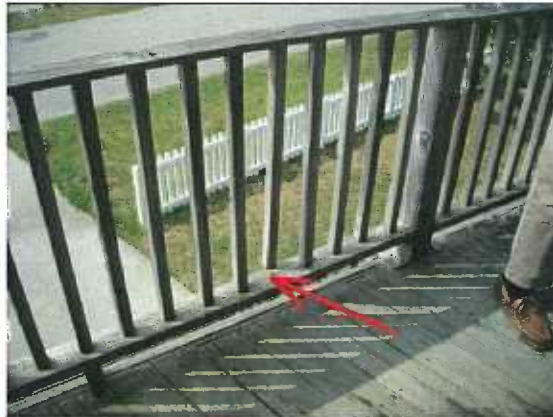
2. **Deck: Front, Pressure Treated Wood** There is one floor joist near the front of the deck that is not properly supported with a metal joist hanger. Several of the handrail pickets are loose and out of place. Close inspection revealed that the nails used to fasten the pickets to the top and bottom rails are rusty and deteriorated and failing to perform their intended function.

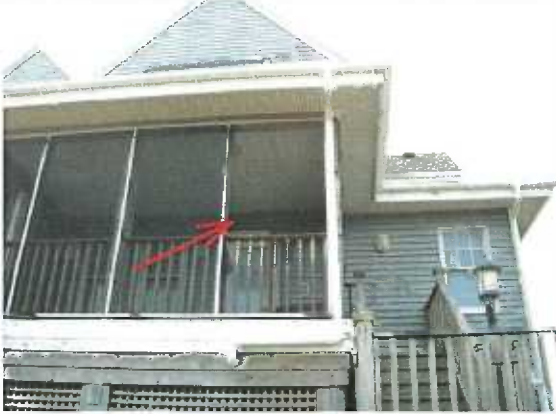
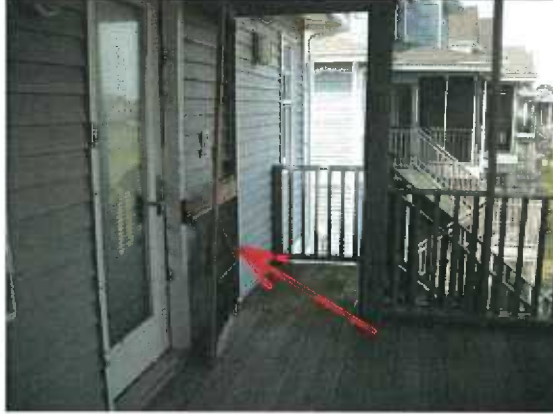
3. **Porch: Rear, Pressure Treated Wood** Screen panels for the porch are missing or damaged. The porch screen door is damaged.

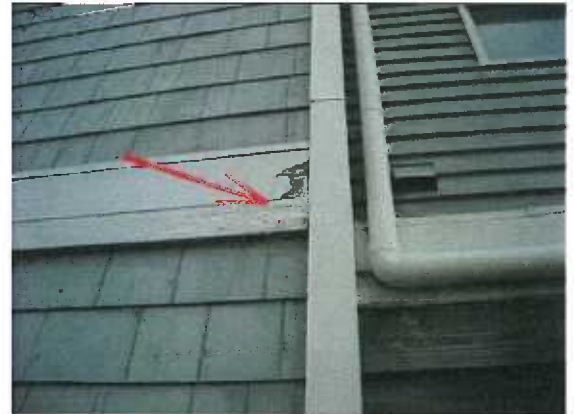
4. Trim: Wood, Aluminum Covered The bump out for the stairs, one piece of the horizontal wood trim is deteriorated.

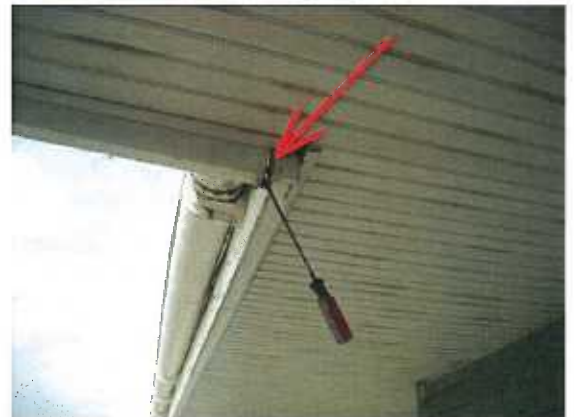
5. Fascia: Wood, wrapped with Aluminum Coil Stock The fascia is deteriorated at the intersection above the front deck.

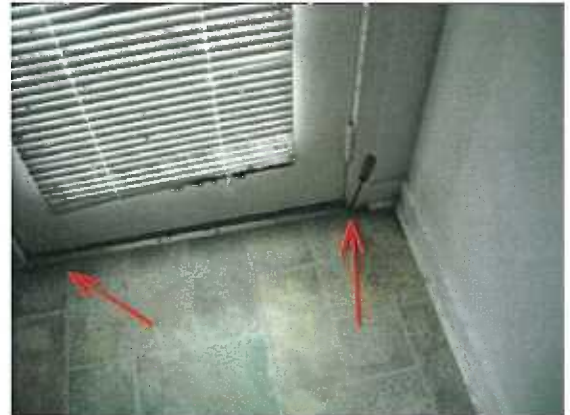
6. Entry Door: Kitchen/Dining Area, Fiberglass, Fullview Glass Moisture is migrating to the inside at the door threshold. The door and threshold need to be adjusted/replaced to stop the moisture migration. The sub floor is also deteriorated just inside of this door.

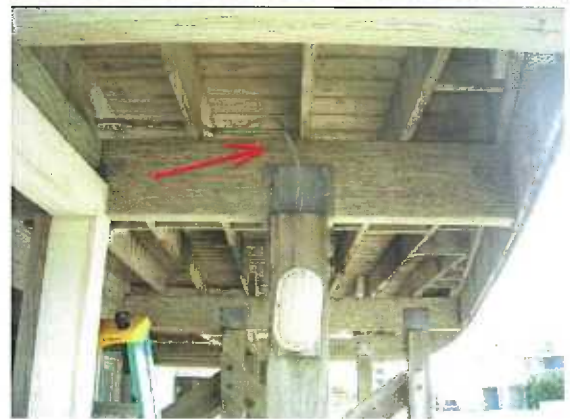
7. Exterior Lighting: Exterior, Surface Mount There is a exterior light under the front deck that was wired with underground romex wiring that should have been installed in electrical conduit. There is a light installed for the rear stairs. The underground romex wiring for this light should have been installed in electrical conduit.

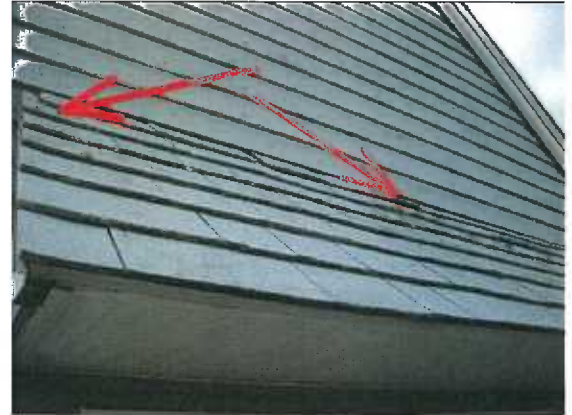
9. Wood Shake Roof: Wood Shake "Eye Brow" Roof There are shingles missing from the small roof above the double windows.

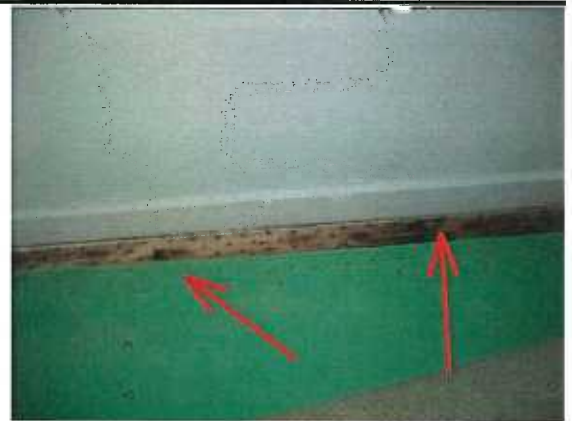
13. Top Floor Rear Bedroom Floor: Carpet The carpet tack strip along the unit party wall, the strip is stained and the tacks are rusty.

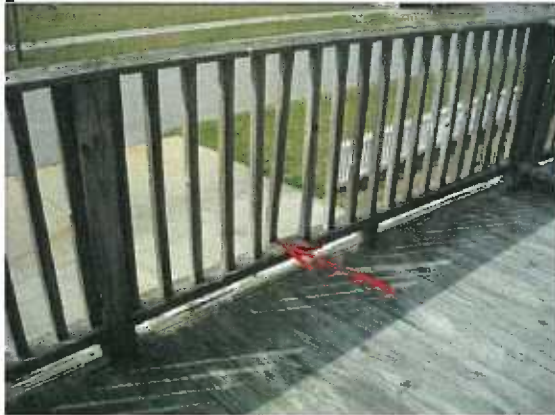
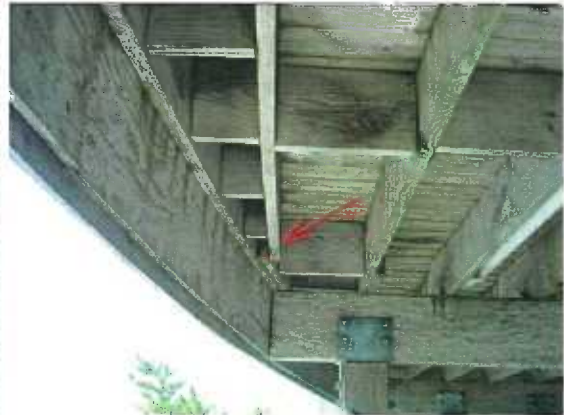
| 5. | <input type="checkbox"/> | <input type="checkbox"/> | <input type="checkbox"/> | <input type="checkbox"/> | <input type="checkbox"/> | <input checked="" type="checkbox"/> | Deck: Front, Pressure Treated Wood There is one floor joist near the front of the deck that is not properly supported with a metal joist hanger. Several of the handrail pickets are loose and out of place. Close inspection revealed that the nails used to fasten the pickets to the top and bottom rails are rusty and deteriorated and failing to perform their intended function. |

1. **Stairs/Landing:** Rear Stairs & Landing, Pressure Treated Wood The wood pickets are loose or out of place. The nails used to secure the pickets are rusty/deteriorated.
2. **Deck:** Front, Pressure Treated Wood There is one floor joist near the front of the deck that is not properly supported with a metal joist hanger. Several of the handrail pickets are loose and out of place. Close inspection revealed that the nails used to fasten the pickets to the top and bottom rails are rusty and deteriorated and failing to perform their intended function.

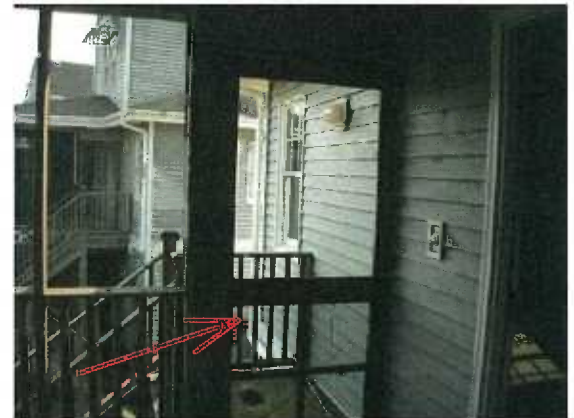
6. ☐ ☐ ☐ ☐ ☒ Porch: Rear, Pressure Treated Wood The porch screen door is damaged.

3. **Porch:** Rear, Pressure Treated Wood The porch screen door is damaged.

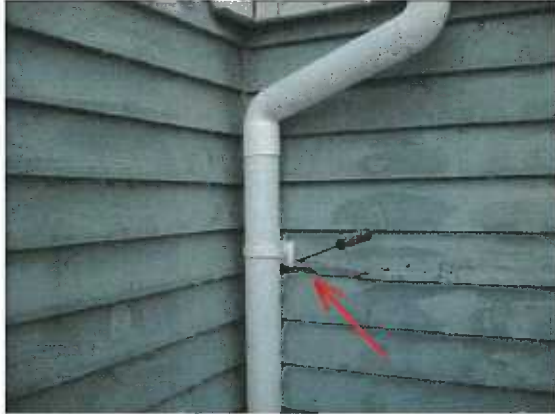
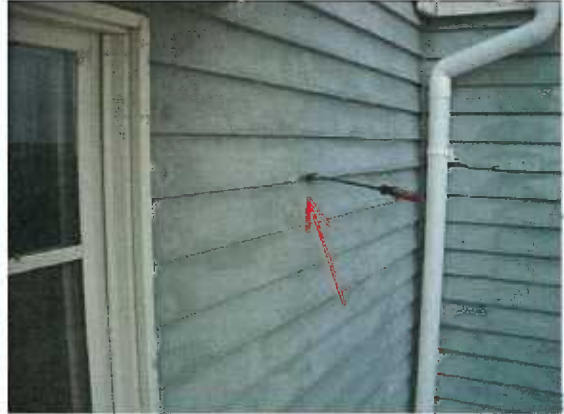
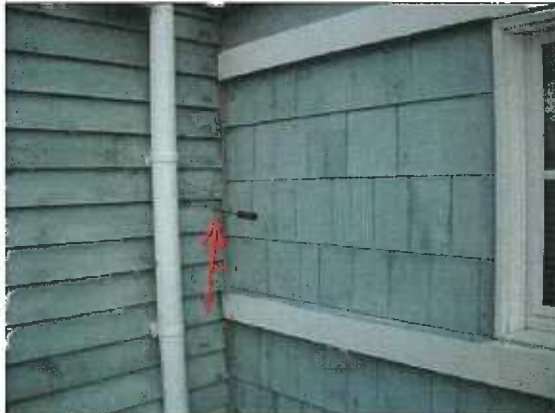
8. ☐ ☐ ☐ ☒ Type: Horizontal Wood Ship Lap Siding Several pieces of the wood lap siding is deteriorated/damaged. All exterior wall surfaces should be examined and re nailed in the areas where is has become loose. The exterior of the house should be pressure washed and repainted.

4. **Exterior Walls Exterior Surface Type:** Horizontal Wood Ship Lap Siding Several pieces of the wood lap siding is deteriorated/damaged. All exterior wall surfaces should be examined and re nailed in the areas where is has become loose. The exterior of the house should be pressure washed and repainted.

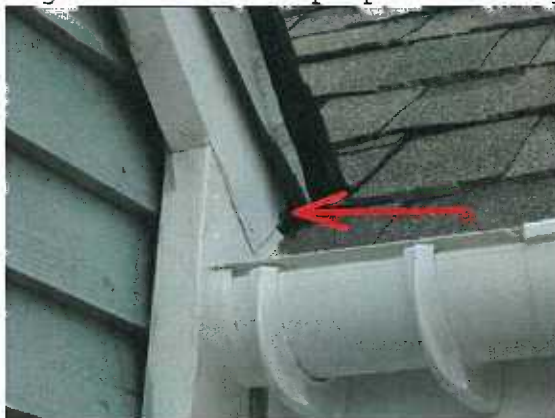
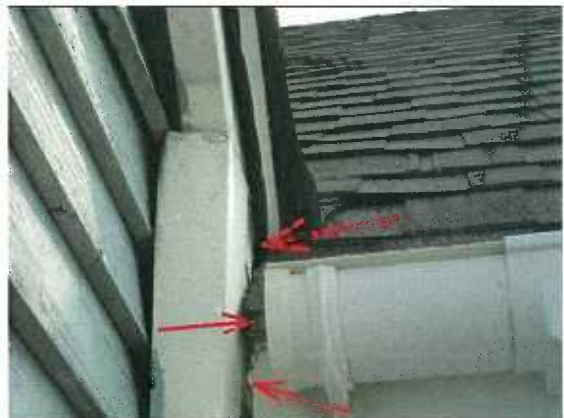
9. ☐ ☐ ☒ ☐ Type: Plywood Panels with machine shake appearance. The machine shake look plywood panels, the nails are loose in several places. The exterior walls should be examined and the loose siding re nailed.
10. ☐ ☐ ☐ ☒ Trim: Wood, Aluminum Covered There is one place where the two units party wall intersect, the corner board and the roof shingles are not fitted together with the proper flashing.

1. **Accent Walls Exterior Surface Type:** Plywood Panels with machine shake appearance. The machine shake look plywood panels, the nails are loose in several places. The exterior walls should be examined and the loose siding re nailed.
2. **Window Screens:** Metal wire There are several screens at various location in the house that are not installed in the windows. No effort was made to inventory the windows.

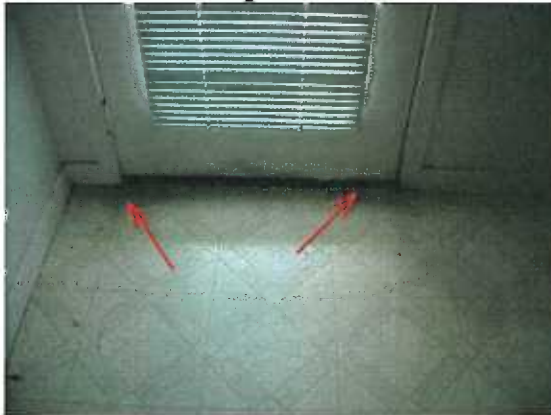
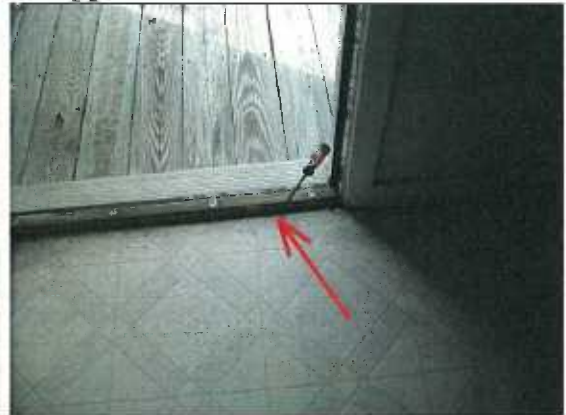
| 16. | <input type="checkbox"/> | <input type="checkbox"/> | <input type="checkbox"/> | <input type="checkbox"/> | <input checked="" type="checkbox"/> | Entry Door: Kitchen/Dining Area, Fiberglass, Fullview Glass The door hardware is possibly defective or needs cleaning and lubricating. Moisture is migrating to the inside at the door threshold. The door and threshold need to be adjusted to stop the moisture migration. The sub-floor just inside this door appears to be deteriorated. |

6. Entry Door: Kitchen/Dining Area, Fiberglass, Fullview Glass The door hardware is possibly defective or needs cleaning and lubricating. Moisture is migrating to the inside at the door threshold. The door and threshold need to be adjusted to stop the moisture migration.
The sub-floor just inside this door appears to be deteriorated.

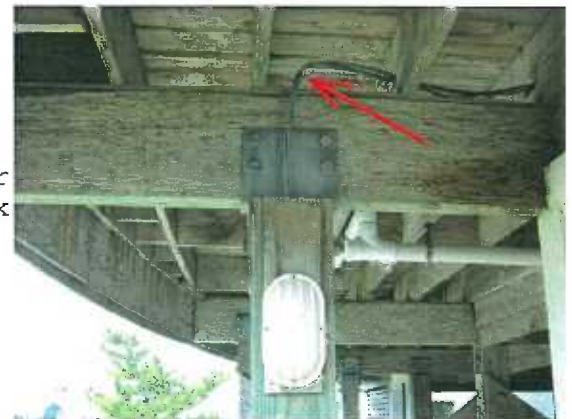
| 19. | <input type="checkbox"/> | <input type="checkbox"/> | <input type="checkbox"/> | <input type="checkbox"/> | <input checked="" type="checkbox"/> | Exterior Lighting: Exterior, Surface Mount

There is a exterior light under the front deck that was wired with underground romex wiring that should have been installed in electrical conduit. There is a light installed for the rear stairs. The underground romex wiring for this light should have been installed in electrical conduit. |

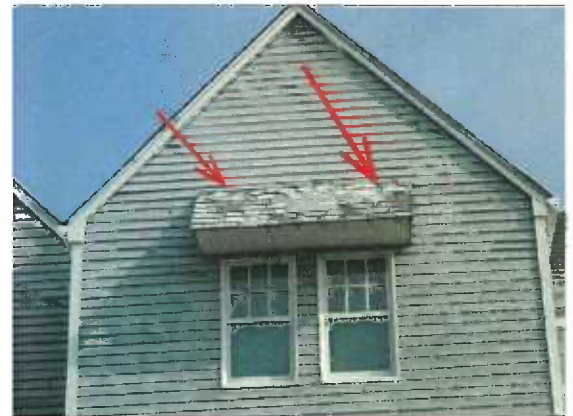
1. Method of Inspection: On roof
2. ☒ ☐ ☐ ☐ ☐ Material: Asphalt shingle
3. Type: Hip & Gable
4. Approximate Age: 14 to 16 years
5. ☒ ☐ ☐ ☐ ☐ Flashing: Metal
6. ☒ ☐ ☐ ☐ ☐ Valleys: Asphalt shingle
7. ☒ ☐ ☐ ☐ ☐ Plumbing Vents: PVC
8. Roof Water Control
9. ☒ ☐ ☐ ☐ ☐ Gutters: Plastic
10. ☒ ☐ ☐ ☐ ☐ Downspouts: Plastic
11. ☐ ☐ ☐ ☐ ☒ "Eye Brow" Roof Wood shake shingle roof above double windows. There are wood shake shingles missing from this roof.

9. "Eye Brow" Roof Wood shake shingle roof above double windows. There are wood shake shingles missing from this roof.

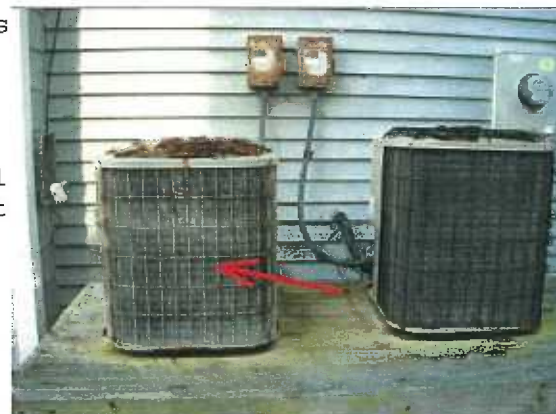
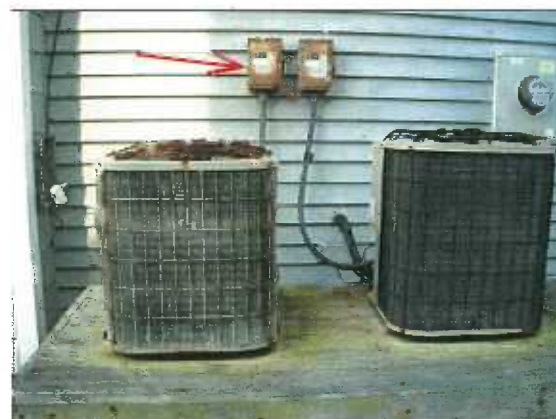
1. ☐ ☐ ☐ ☐ ☒ A/C System Operation: Inoperative
2. ☒ ☐ ☐ ☐ ☐ Condensate Removal: Plastic tubing
3. ☒ ☐ ☐ ☐ ☐ Exterior Unit: Mounted on wooden platform
4. Manufacturer: Carrier
5. Area Served: Top Floor Approximate Age: 14 to 16 years
6. Fuel Type: Electric Temperature Differential: x
7. Type: Heat pump Capacity: 1.5 ton
8. ☐ ☐ ☐ ☐ ☒ Visible Coil: Copper core with aluminum fins
The aluminum fins surrounding the copper coil are becoming deteriorated and falling away from the copper coil. The aluminum fins are present to dissipate the heat from the copper coil and when the fins are no longer present the coil will over heat and the condenser will cease to function.
9. ☒ ☐ ☐ ☐ ☐ Refrigerant Lines: Serviceable condition
10. ☐ ☐ ☐ ☒ ☐ Electrical Disconnect: Tumble switch The HVAC electric disconnect box is very rusty.

4. **East Side AC System Electrical Disconnect:** Tumble switch The HVAC electric disconnect box is very rusty.

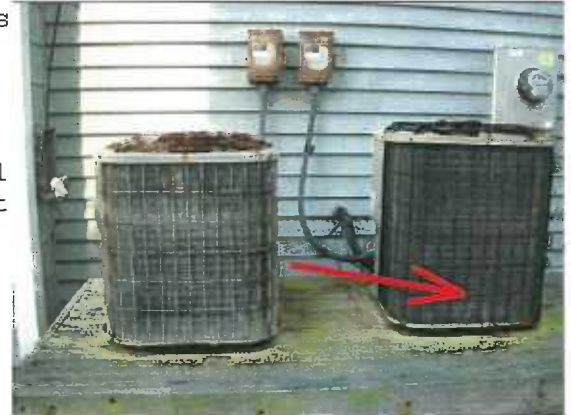
18. ☐☐☐☐☒ **Visible Coil:** Copper core with aluminum fins
The aluminum fins surrounding the copper coil are becoming deteriorated and falling away from the copper coil. The aluminum fins are present to dissipate the heat from the copper coil and when the fins are no longer present the coil will over heat and the condenser will cease to function.

11. East Side AC System Visible Coil: Copper core with aluminum fins The aluminum fins surrounding the copper coil are becoming deteriorated and falling away from the copper coil. The aluminum fins are present to dissipate the heat from the copper coil and when the fins are no longer present the coil will over heat and the condenser will cease to function.

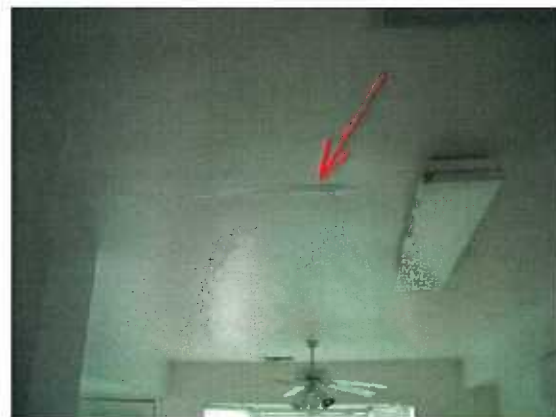
1. ☒ ☐ ☐ ☐ ☐ Cooking Appliances: General Electric
2. ☒ ☐ ☐ ☐ ☐ Ventilator: General Electric
3. ☐ ☐ ☒ ☐ ☐ Dishwasher: General Electric
4. ☒ ☐ ☐ ☐ ☐ Refrigerator: General Electric
5. ☒ ☐ ☐ ☐ ☐ Sink: Stainless Steel, Double Bowl
6. ☒ ☐ ☐ ☐ ☐ Electrical: Lights & Receptacles
7. ☐ ☐ ☒ ☐ ☐ Plumbing/Fixtures: Generic
8. ☐ ☐ ☐ ☒ ☐ Counter Tops: Laminate and composite materials There is a small dent in the surface of the counter top.
9. ☒ ☐ ☐ ☐ ☐ Cabinets: Flush Laminate
10. ☐ ☐ ☐ ☐ ☒ Ceiling: Drywall There is a crack in the drywall ceiling.

18. Kitchen & Dining Area, Main Level Kitchen Ceiling: Drywall There is a crack in the drywall ceiling.

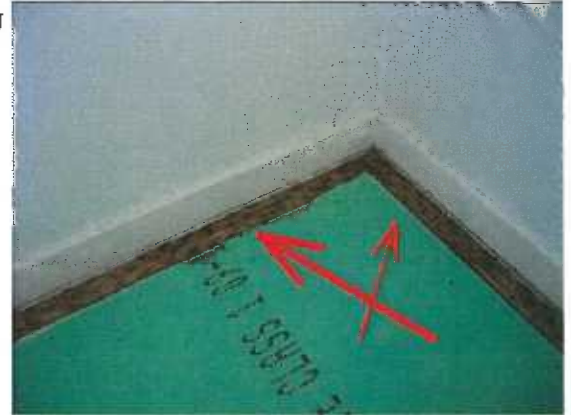
4. ☐ ☐ ☐ ☐ ☒ Floor: Carpet The carpet tack strip along the unit party wall, the strip is stained and the tacks are rusty.

20. Top Floor Rear Bedroom Floor: Carpet The carpet tack strip along the unit party wall, the strip is stained and the tacks are rusty.

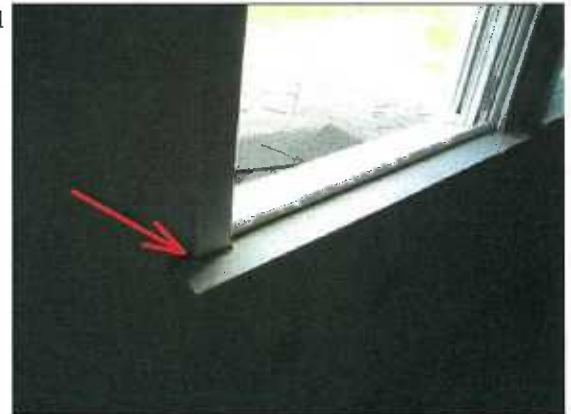
5. ☒ ☐ ☐ ☐ ☐ Doors: Painted, Flush Solid Core
6. ☐ ☐ ☐ ☐ ☒ Windows: Andersen, Double Hung, Tilt and Wash The wood window sill does not fit as it was originally installed.

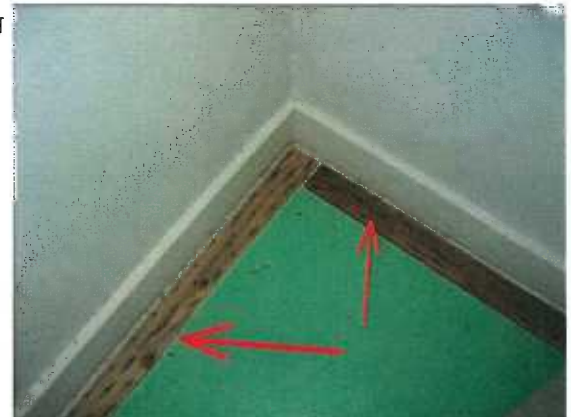
9. ☒ ☐ ☐ ☐ ☐ Closet: Single
10. ☒ ☐ ☐ ☐ ☐ Ceiling: Drywall
11. ☒ ☐ ☐ ☐ ☐ Walls: Drywall
12. ☐ ☐ ☐ ☐ ☒ Floor: Carpet The carpet tack strip along the unit party wall, the strip is stained and the tacks are rusty.

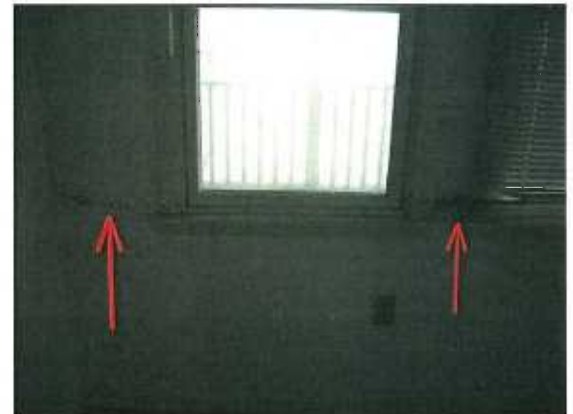
7. ☐ ☐ ☐ ☒ ☐ Closet: Single There are signs of organic growth on the closet door.
8. ☒ ☐ ☐ ☐ ☐ Ceiling: Drywall
9. ☐ ☐ ☐ ☐ ☒ Walls: Drywall There is damage to the drywall in the area of the double windows. It appears that someone left the windows open and the blinds moving around caused the damage to the vinyl.

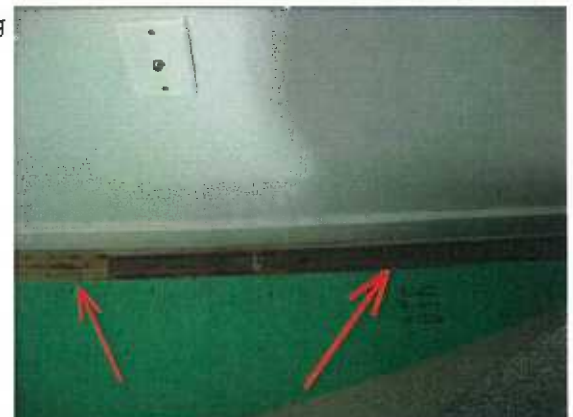
10. ☐ ☐ ☐ ☐ ☒ Floor: Carpet The carpet tack strip along the unit party wall, the strip is stained and the tacks are rusty.

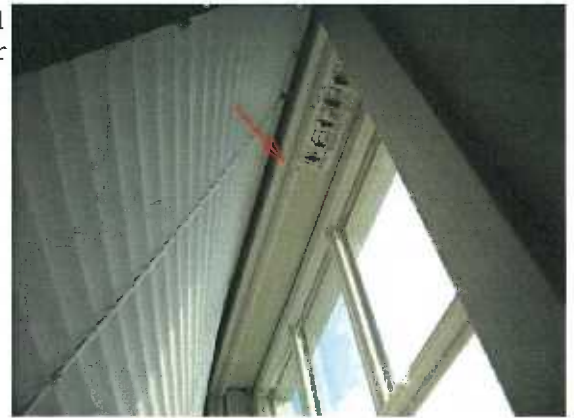
21. ☒ ☐ ☐ ☐ ☐ Ceiling: Drywall
 22. ☒ ☐ ☐ ☐ ☐ Walls: Drywall
 23. ☒ ☐ ☐ ☐ ☐ Floor: Carpet
 24. ☐ ☐ ☐ ☒ ☐ Windows: Andersen, Double Hung, Tilt and Wash There are drip marks on the header vinyl of the center window.

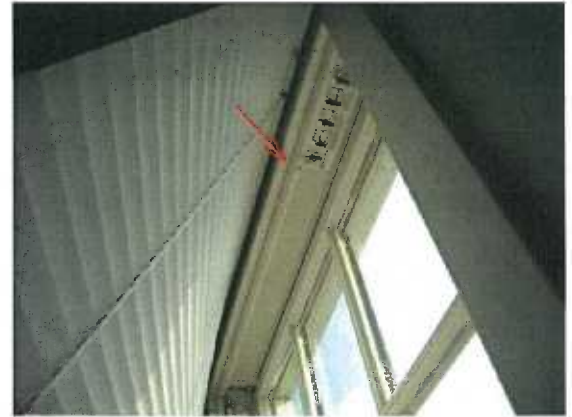
8. Ground Level Utility/Storage Room Living Space Walls: Paneling, Painted There is presence of organic growth on the painted plywood walls of this room.
9. Ground Level Utility/Storage Room Living Space Doors: Painted, Flush Solid Core There is organic growth on the surface of the door.
10. Main Level Living Area Living Space Closet: Single There are signs of organic growth on the closet door.
11. Stair Well Living Space Windows: Andersen, Double Hung, Tilt and Wash There are drip marks on the header vinyl of the center window.

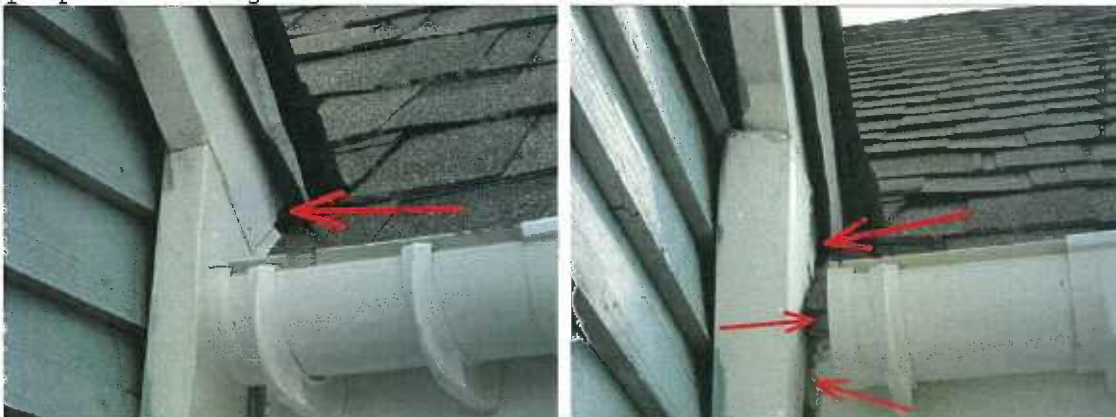
5. Trim: Wood, Aluminum Covered There is one place where the two units party wall intersect, the corner board and the roof shingles are not fitted together with the proper flashing.

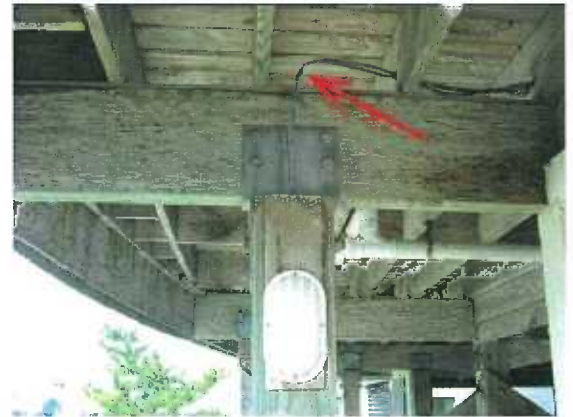
7. Exterior Lighting: Exterior, Surface Mount There is a exterior light under the front deck that was wired with underground romex wiring that should have been installed in electrical conduit. There is a light installed for the rear stairs. The underground romex wiring for this light should have been installed in electrical conduit.

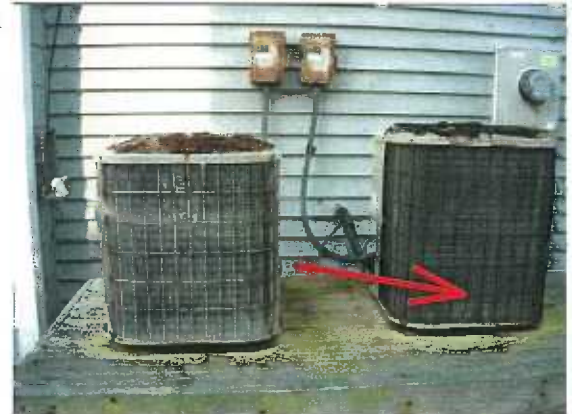
12. East Side AC System A/C System Operation: Inoperative
13. East Side AC System Exterior Unit: Mounted on wooden platform
14. East Side AC System Visible Coil: Copper core with aluminum fins The aluminum fins surrounding the copper coil are becoming deteriorated and falling away from the copper coil. The aluminum fins are present to dissipate the heat from the copper coil and when the fins are no longer present the coil will over heat and the condenser will cease to function.

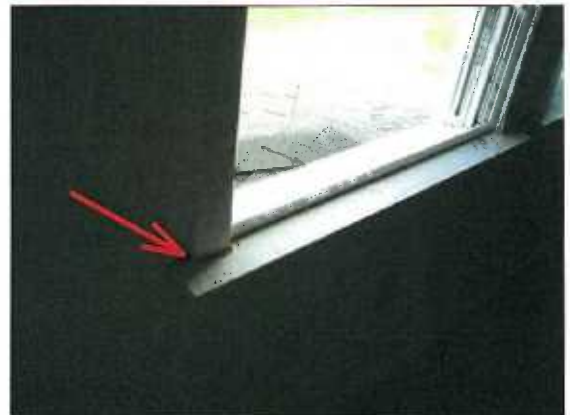
21. Top Floor Rear Bedroom Windows: Andersen, Double Hung, Tilt and Wash The wood window sill does not fit as it was originally installed.

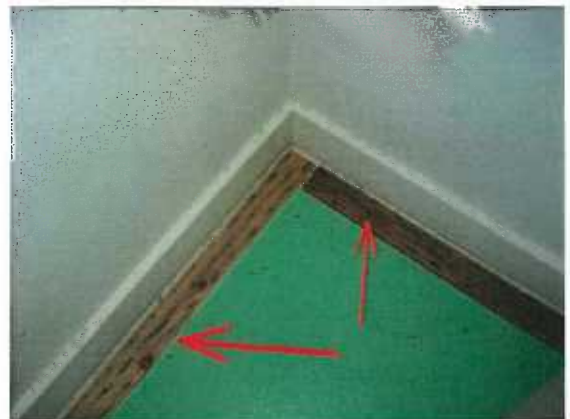
22. Top Floor Front Bedroom Floor: Carpet The carpet tack strip along the unit party wall, the strip is stained and the tacks are rusty.

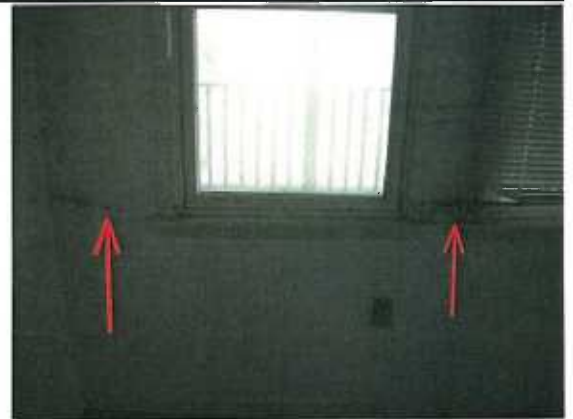
23. Main Level Living Area Living Space Walls: Drywall There is damage to the drywall in the area of the double windows. It appears that someone left the windows open and the blinds moving around caused the damage to the vinyl.

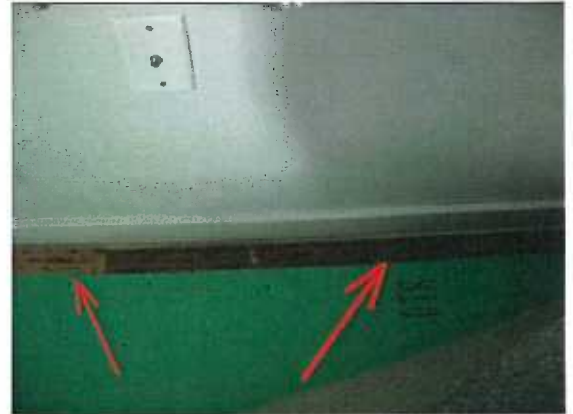
24. Main Level Living Area Living Space Floor: Carpet The carpet tack strip along the unit party wall, the strip is stained and the tacks are rusty.
